# Situation Photo Log

Wednesday, December 19, 2012

Kalamazoo River / Enbridge Spill

Prepared by:  
Larry Rader  
START-USEPA  
Situation Unit Leader

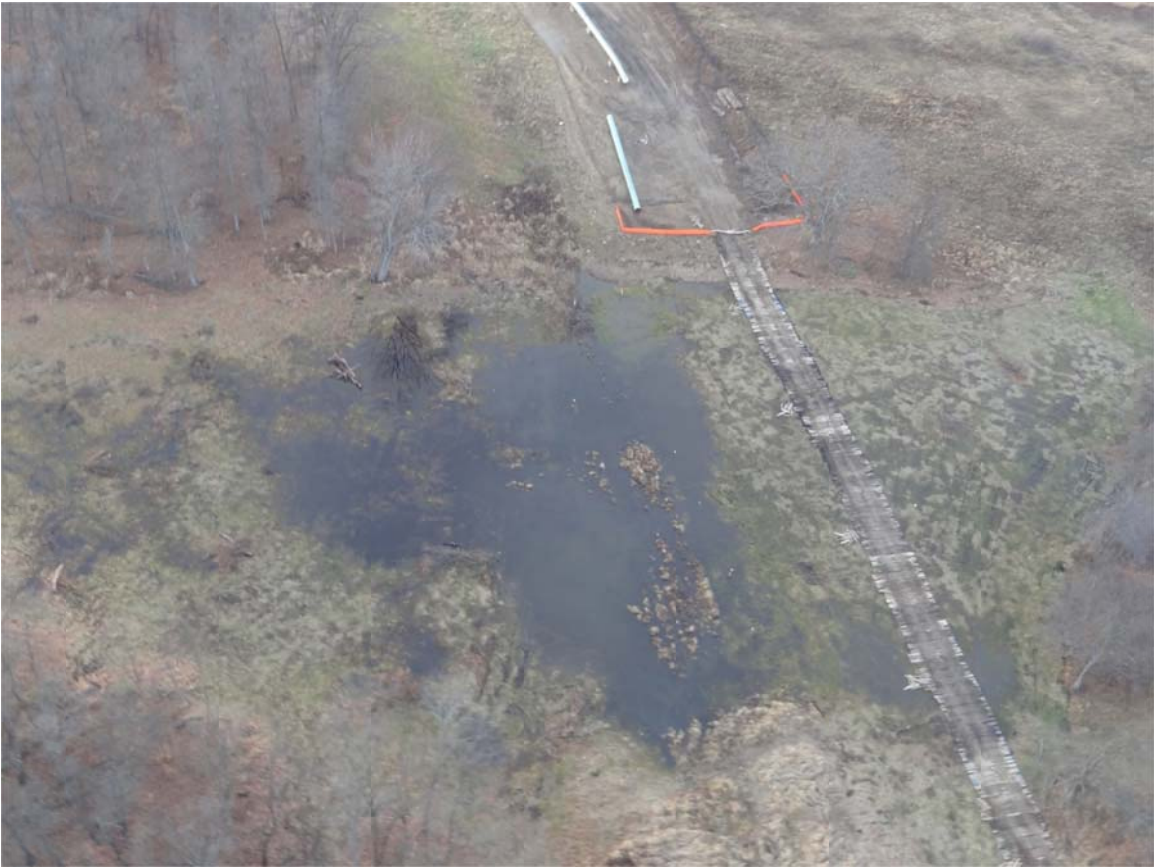
**1. Source Area, no sheen or ice observed.**

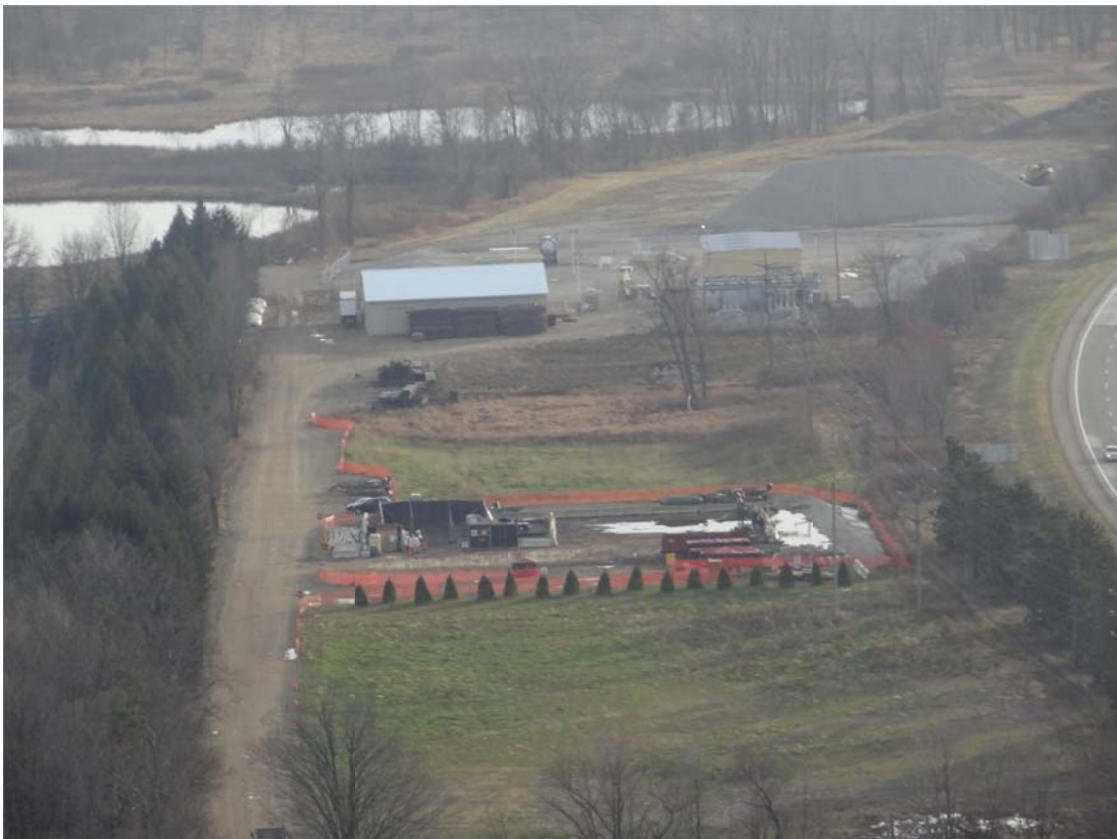
**2. Frac Tank City, no decon operations observed.**

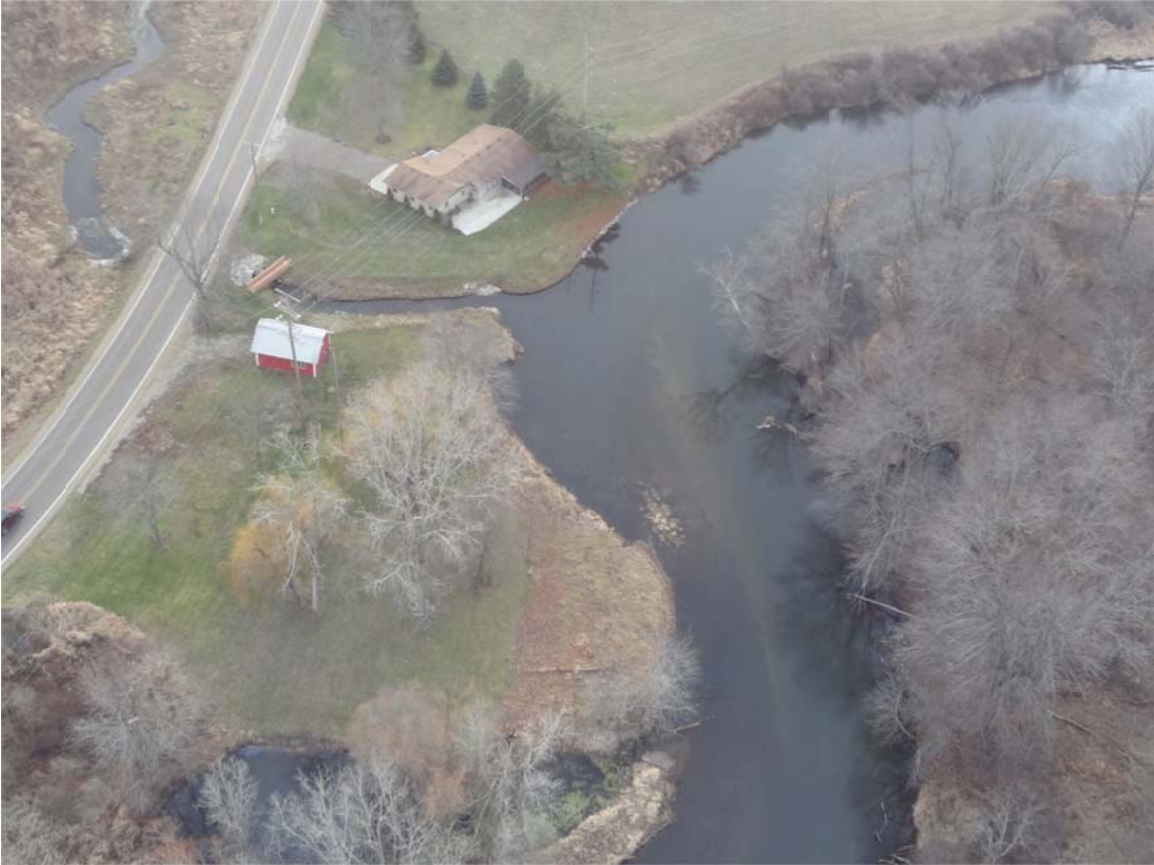
**3. Confluence, sheen observed in pond north of confluence. Sheen test determined that sheen was biogenic in origin.**

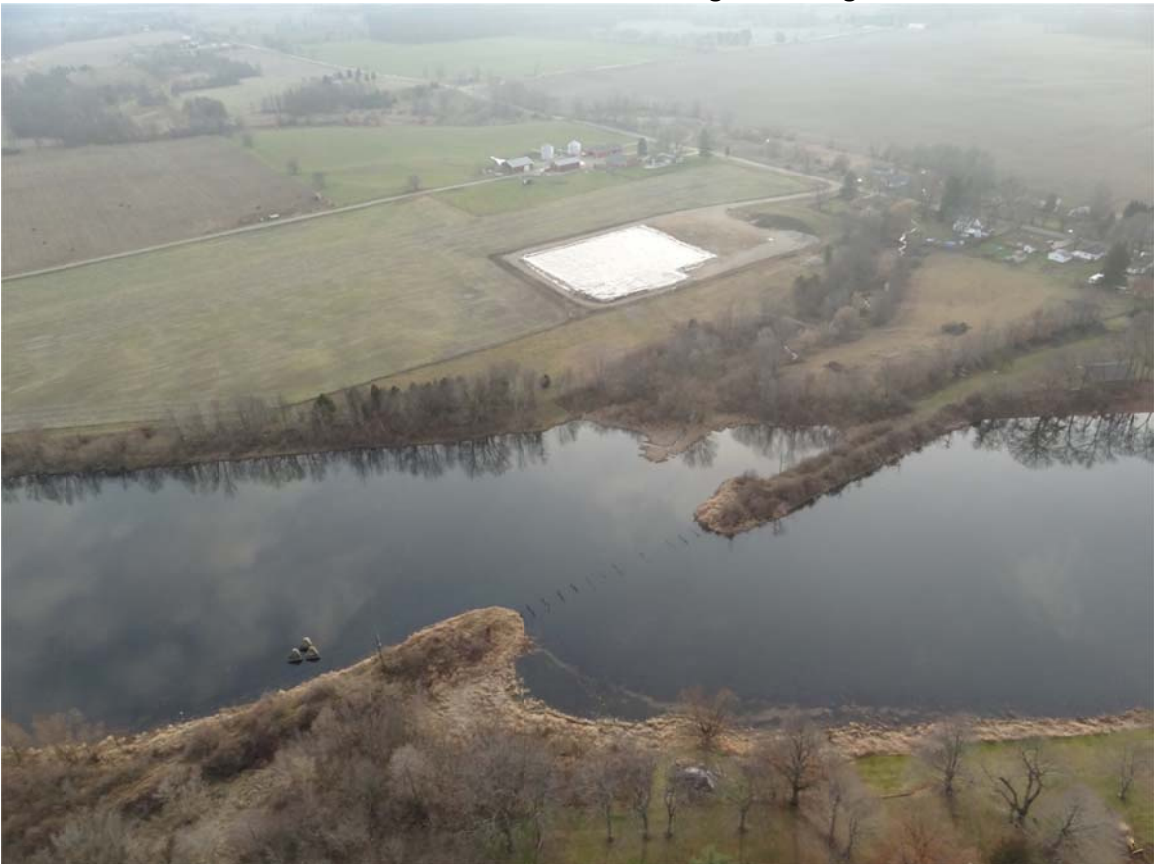
**4. Ceresco Dam trestle RDB, no sheen or ice observed.**

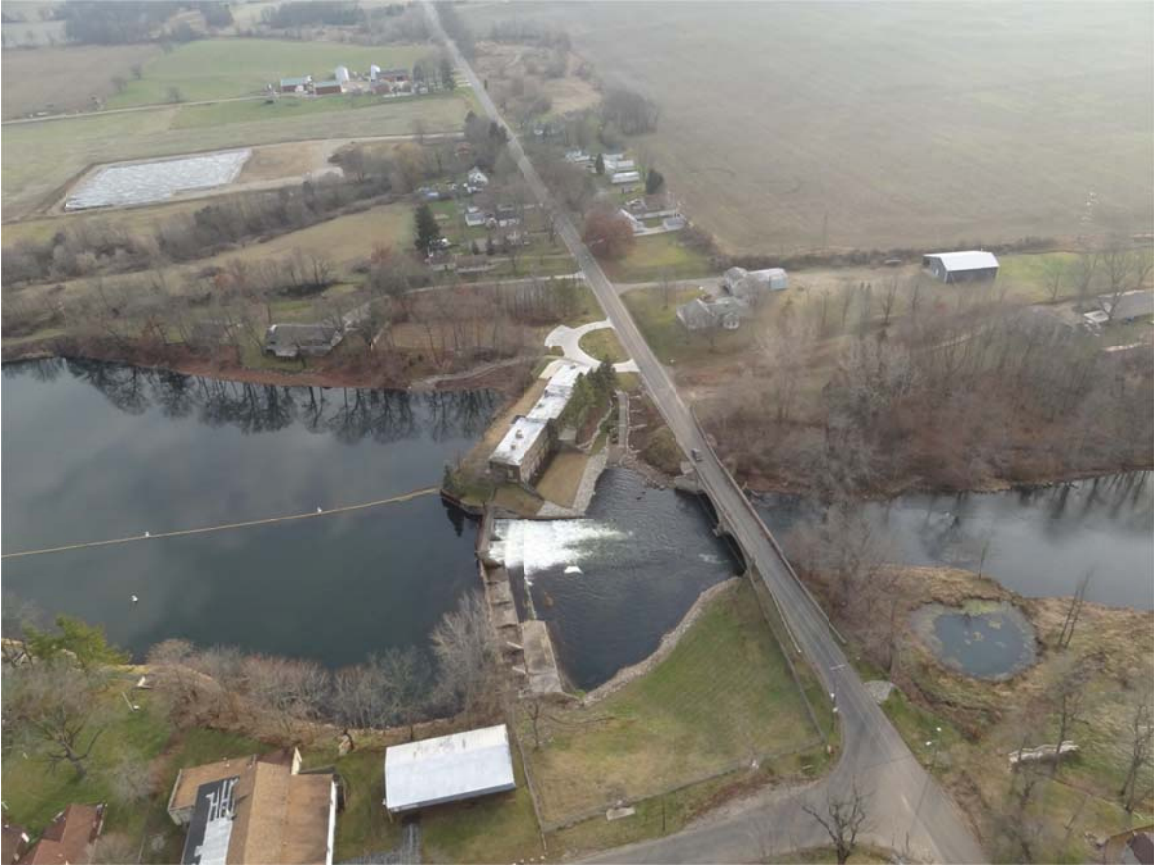
5. Ceresco Dam control point. No sheen observed from overflight. Sheen observed during morning ground inspection.

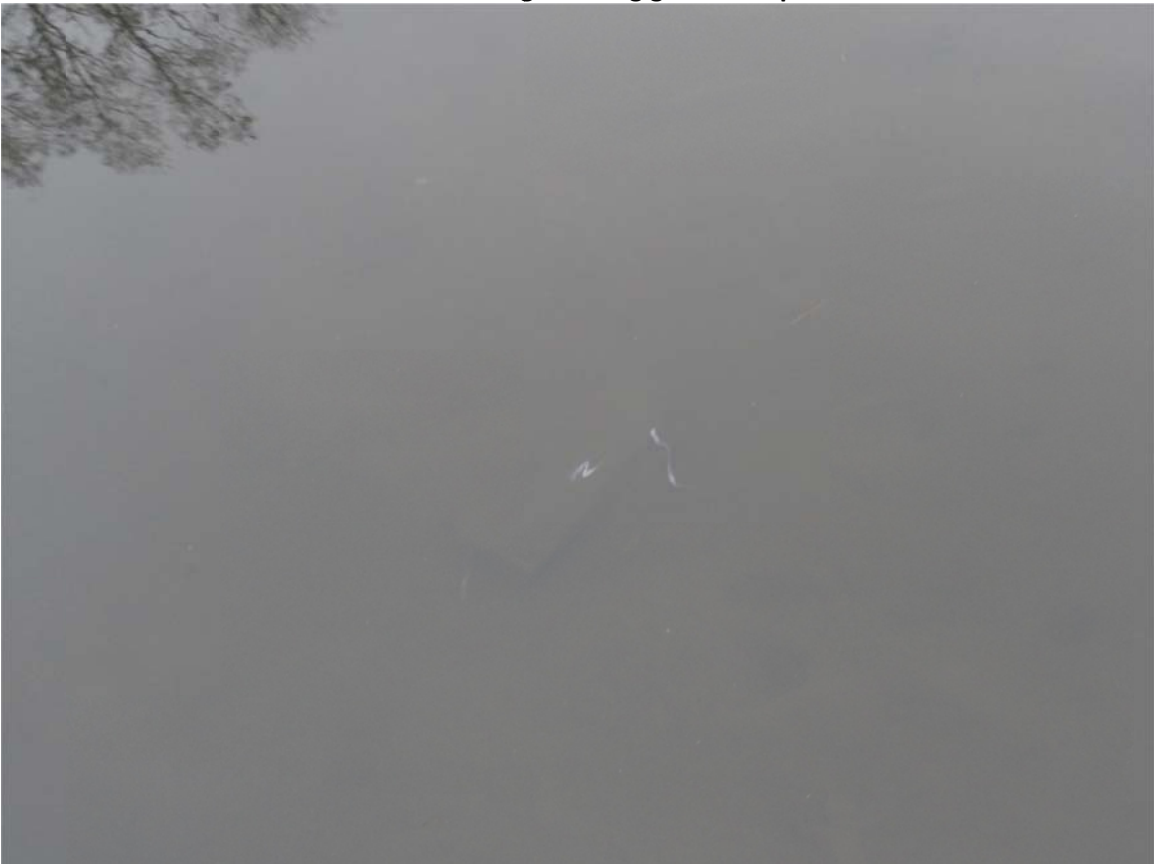
6. Tar globules and sheen observed along Ceresco Dam control point.

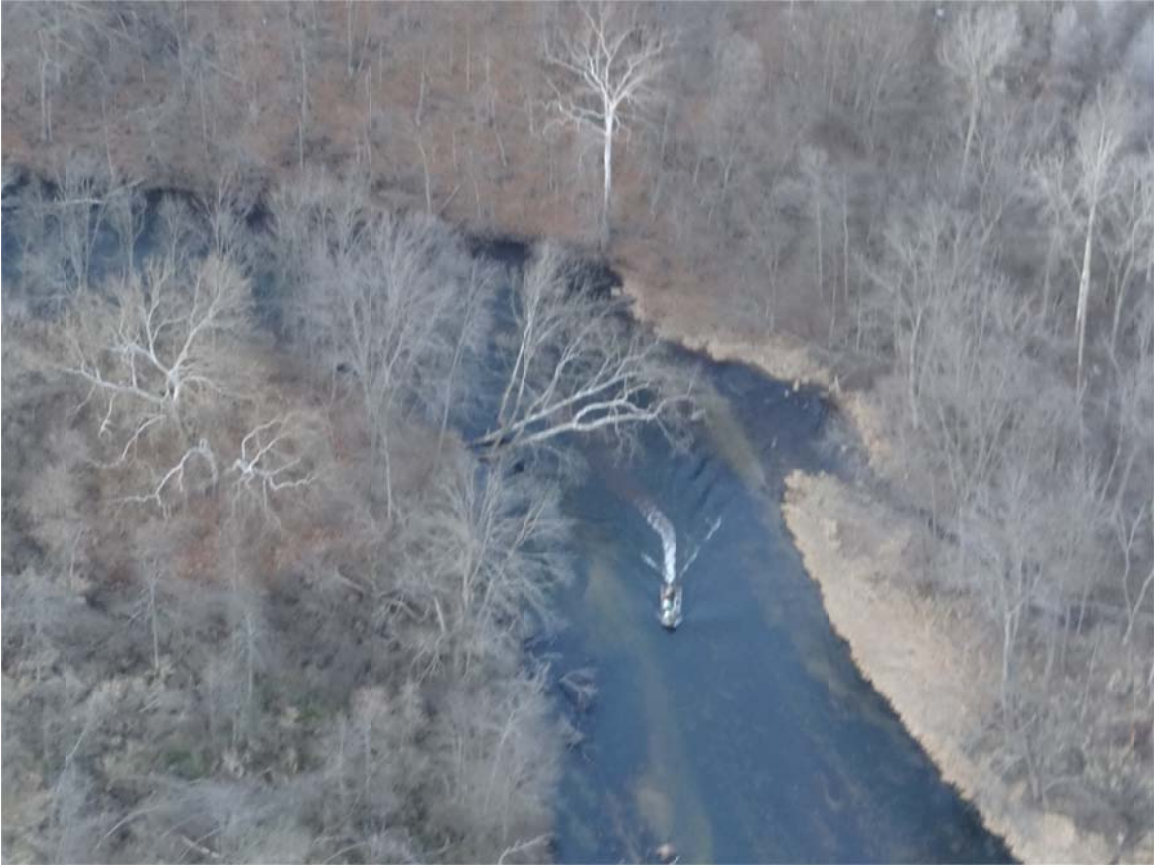
7. Observed RI crew on river near MP 12.0.

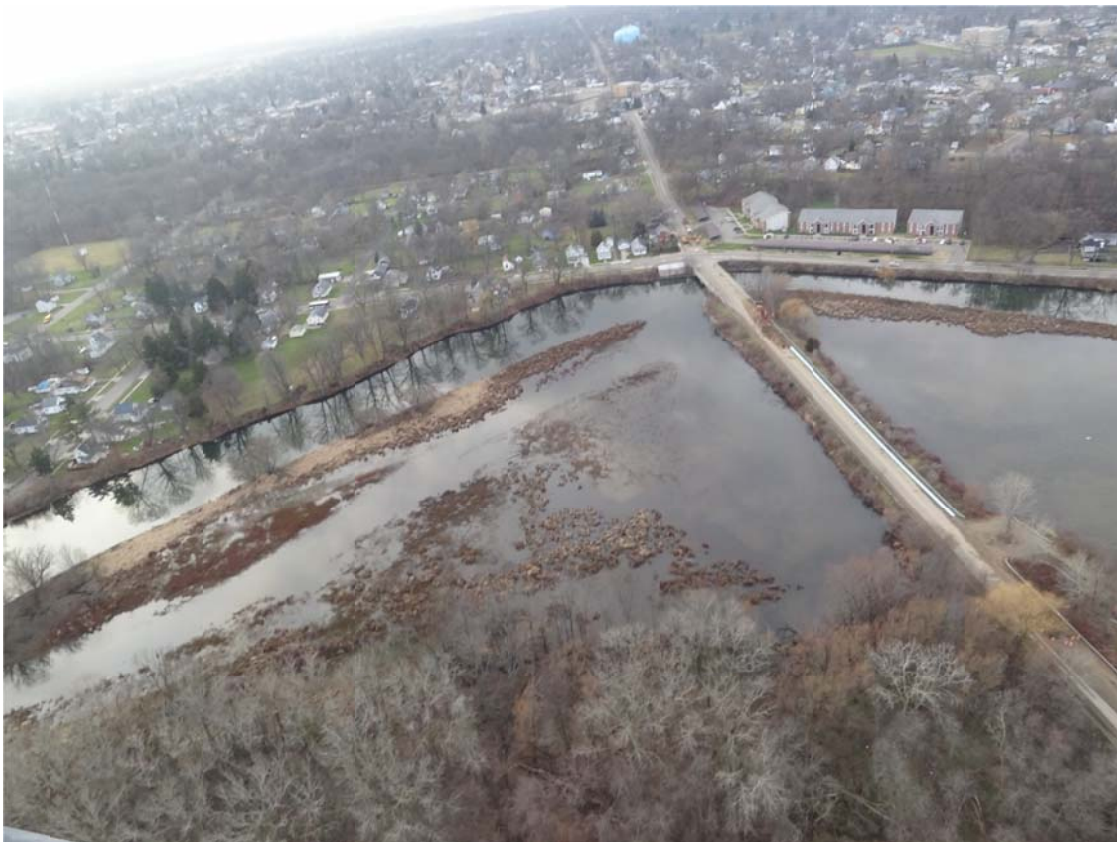
8. South Mill Pond, no sheen or ice observed.

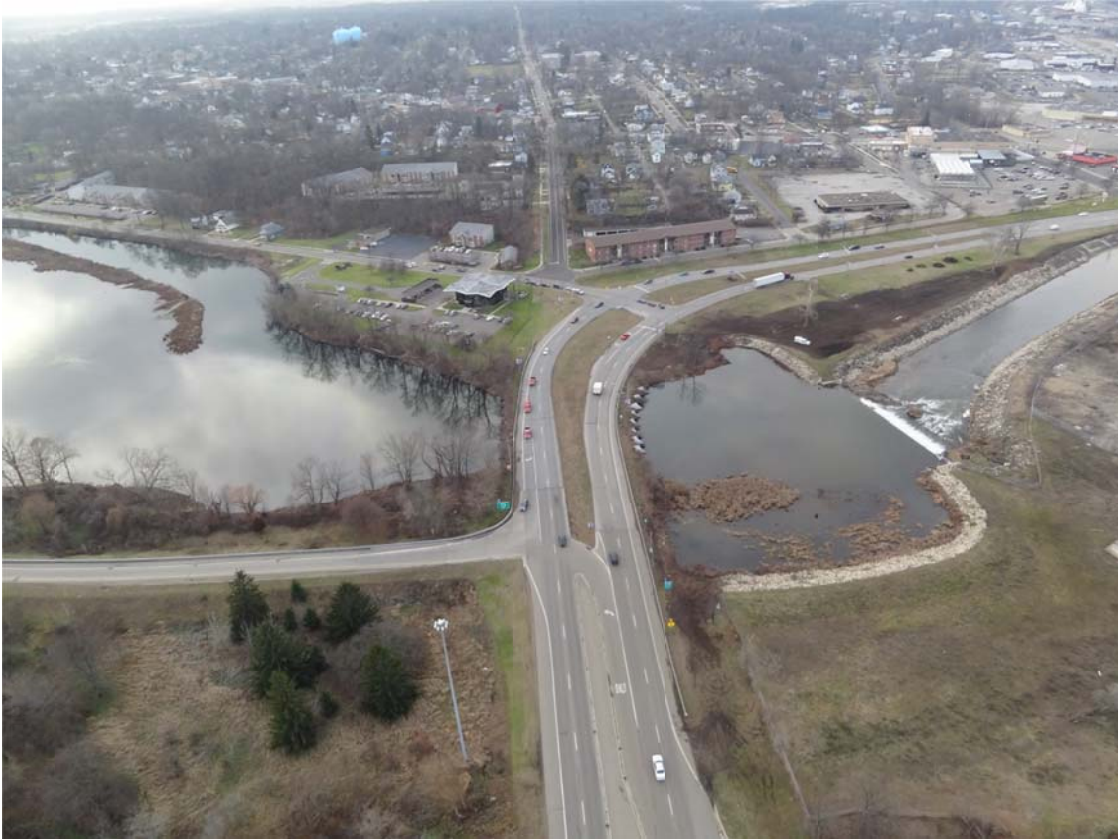
9. MP15.75 Battle Creek Spillway, no sheen observed during overflight.

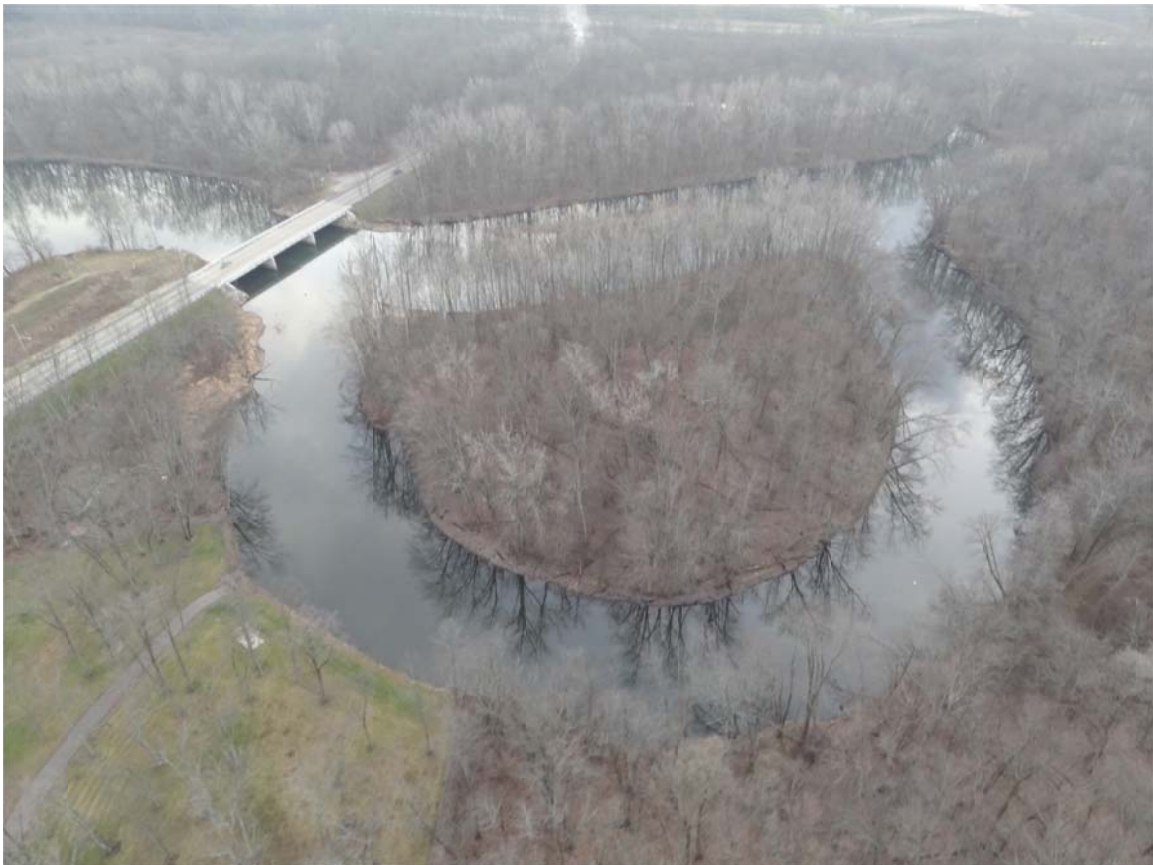
10. MP21.5, no ice or activity observed.

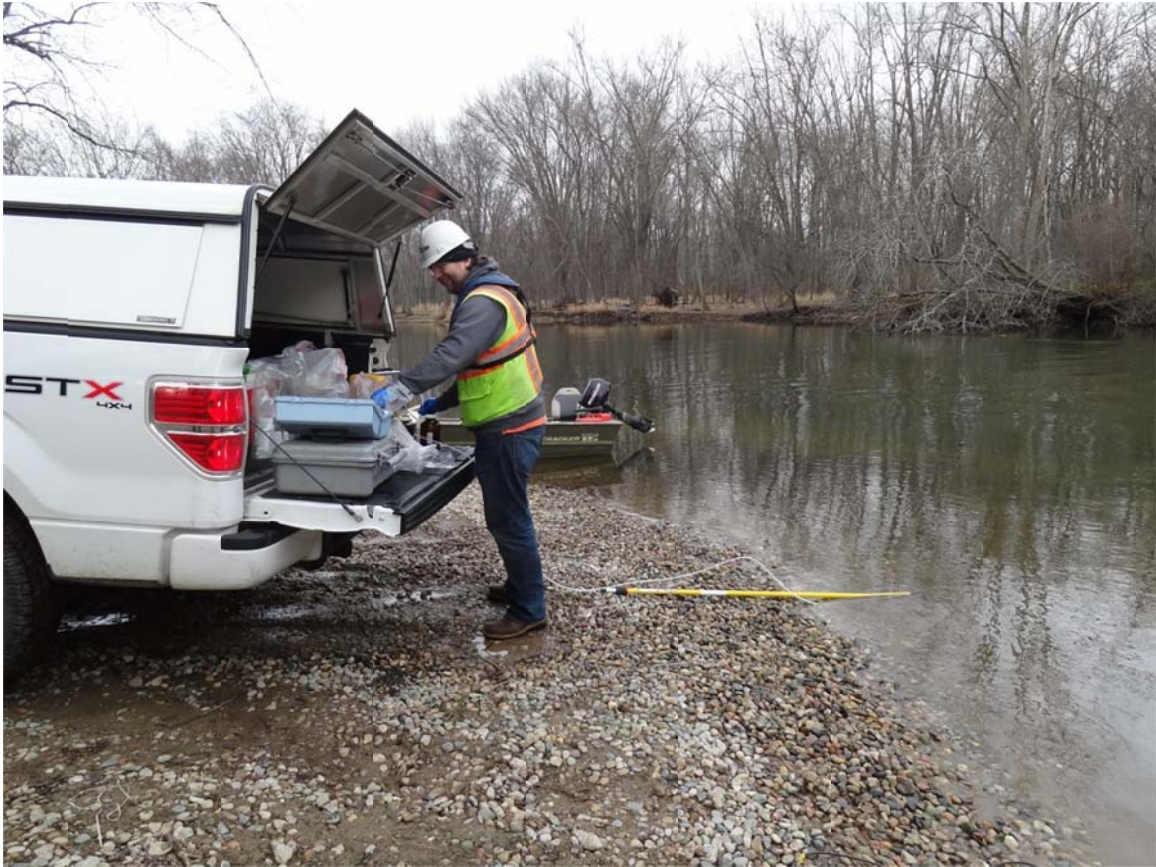
11. E0.5 boat launch, observed crew collecting surface water samples.

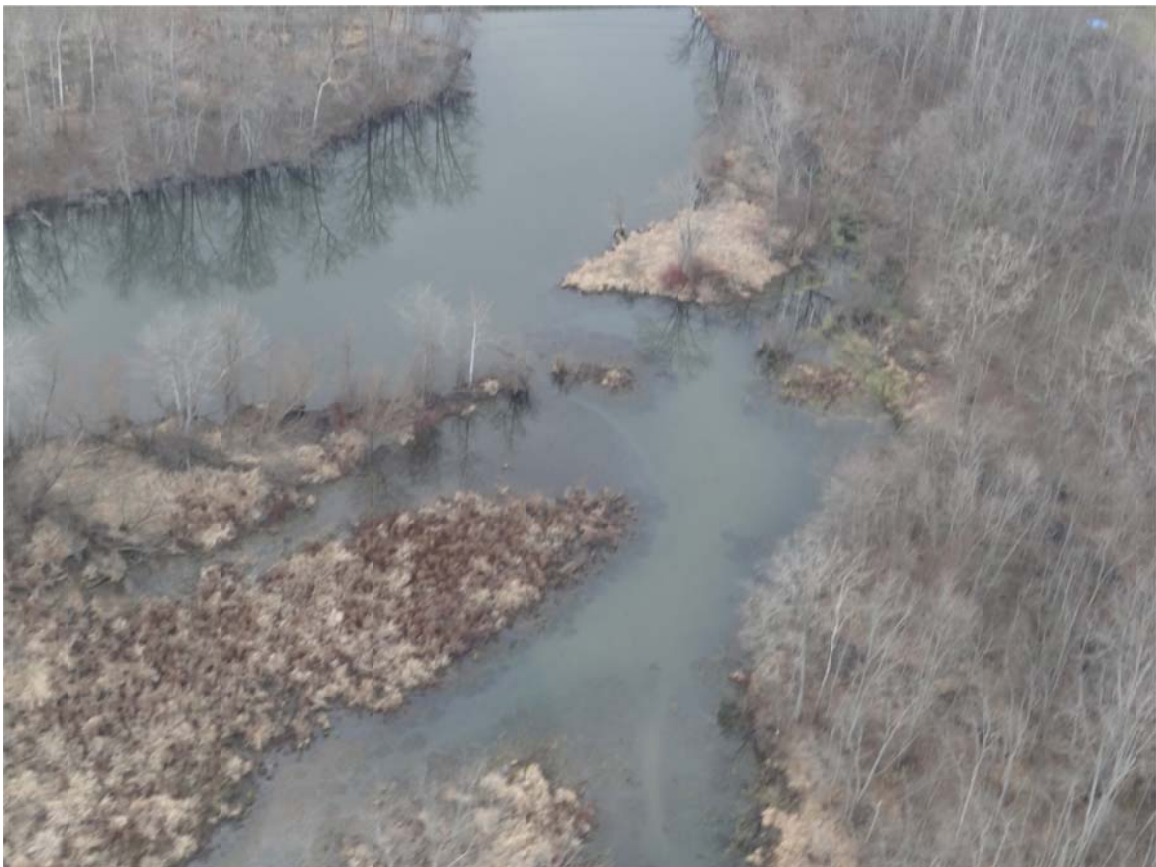
12. MP36.5 RDB, no sheen observed during ground inspection or overflight.

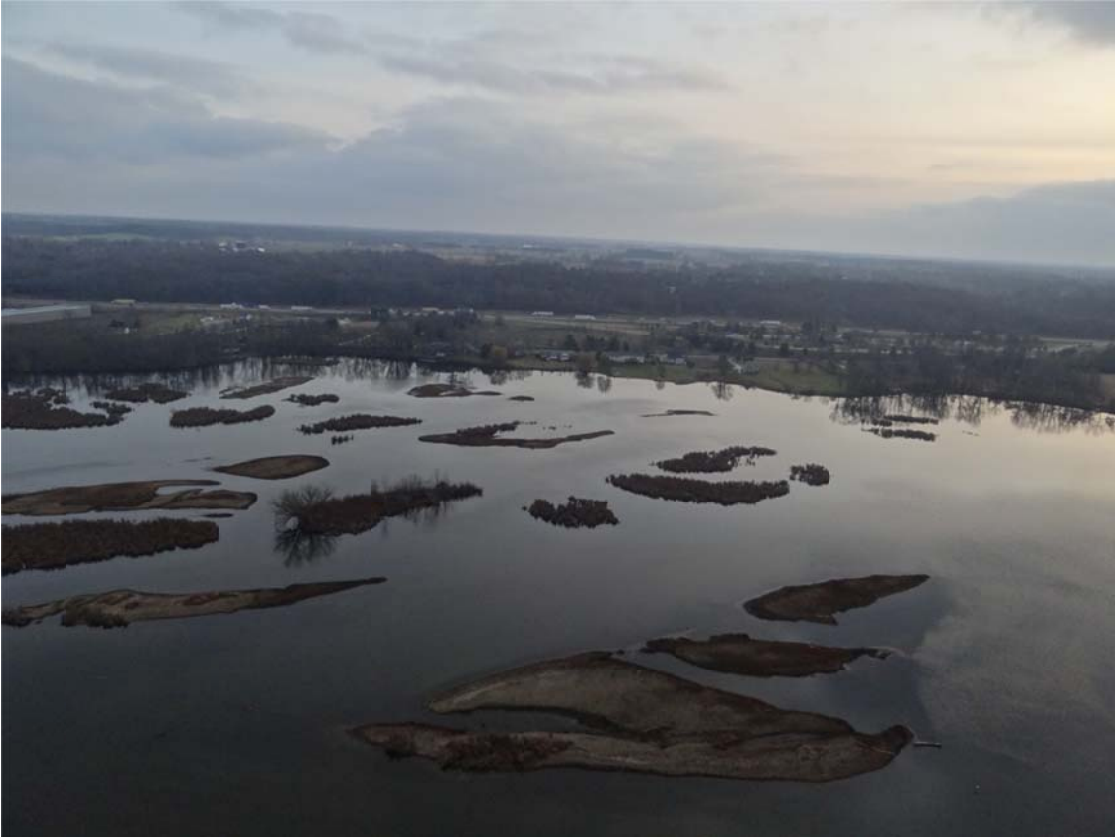
13. Morrow Lake Delta, no sheen or ice observed.

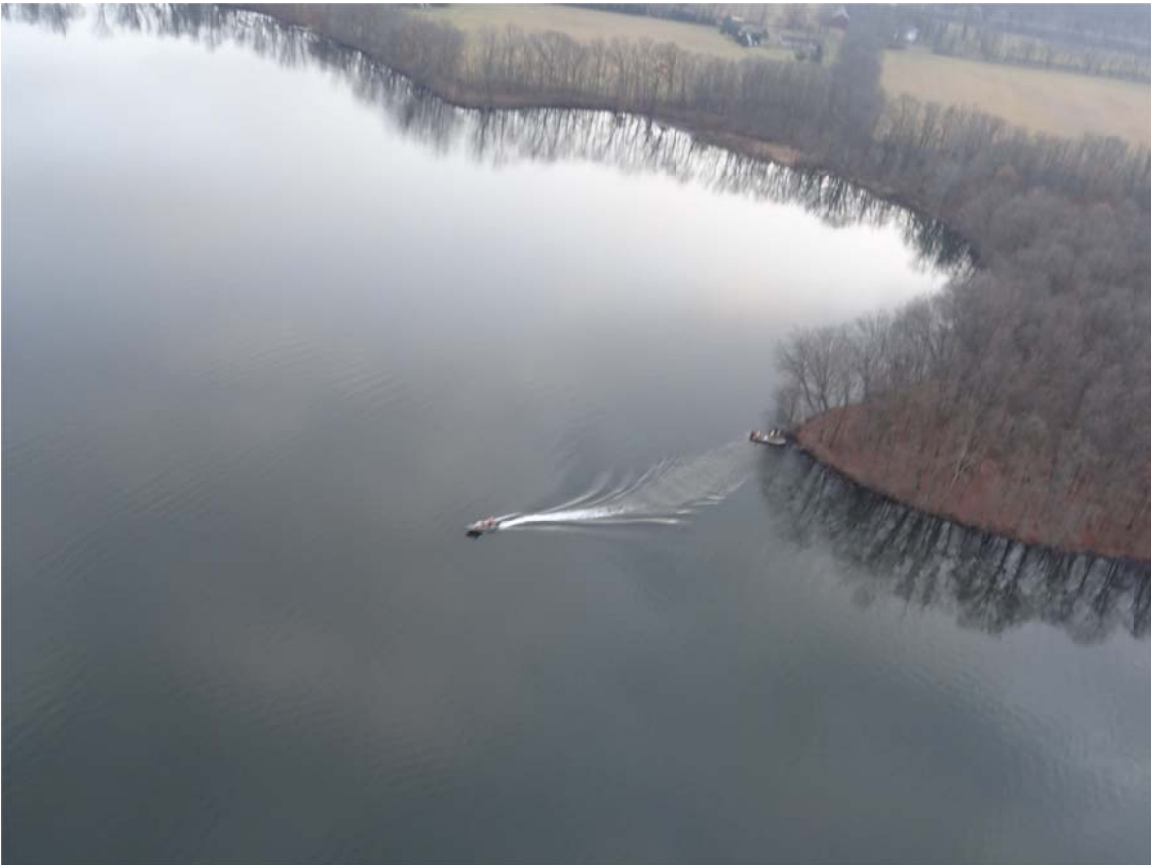
14. MP37.5 LDB, observed a bathymetry crew surveying at former E4.0 boom locations.

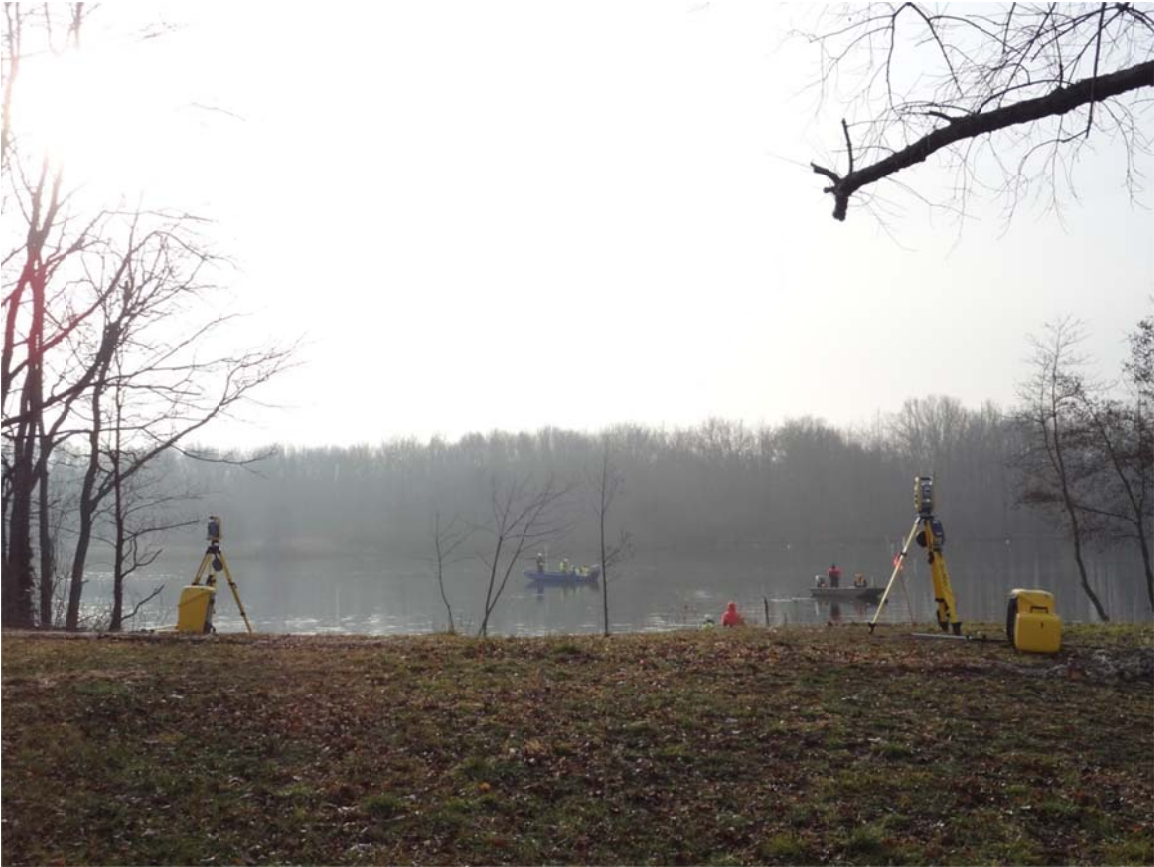
**15. Observed bathymetry crews and survey equipment along RDB at former E4.0 boom location.**

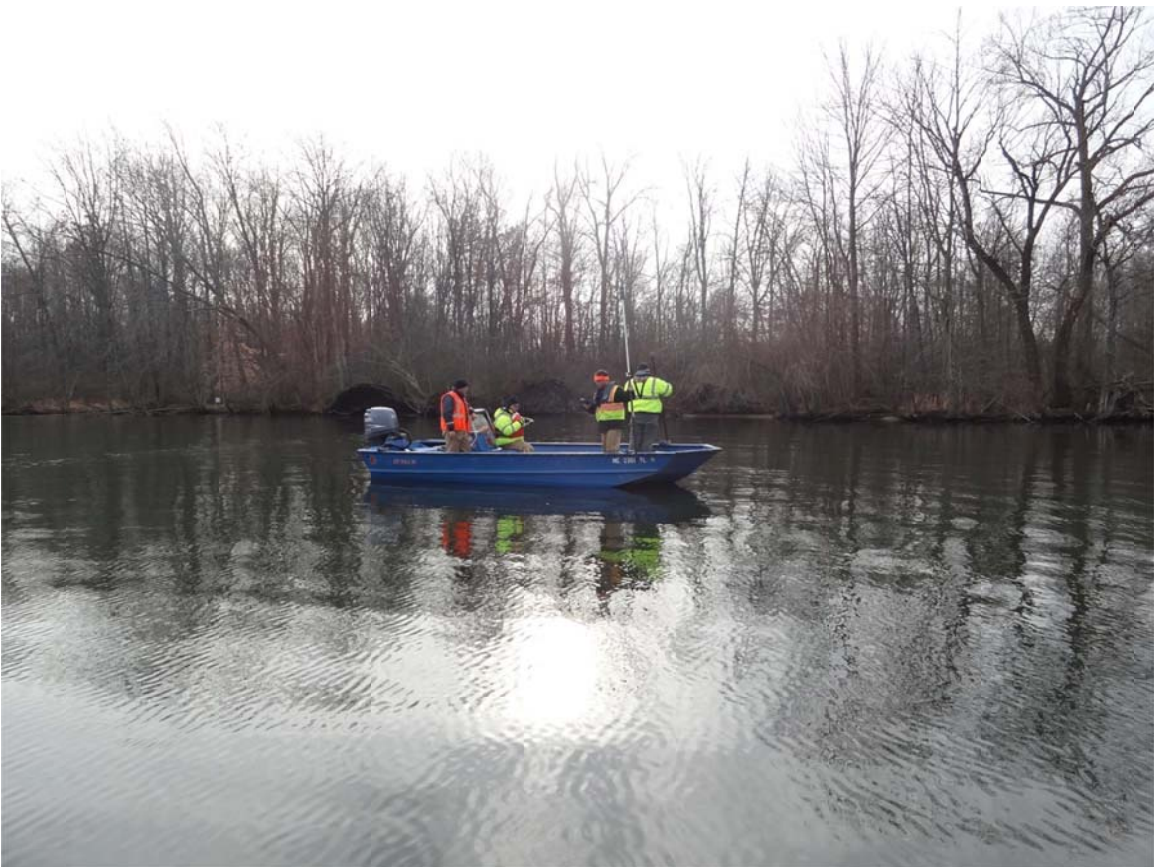
**16. MP37.75, bathymetry crews observed along LDB.**

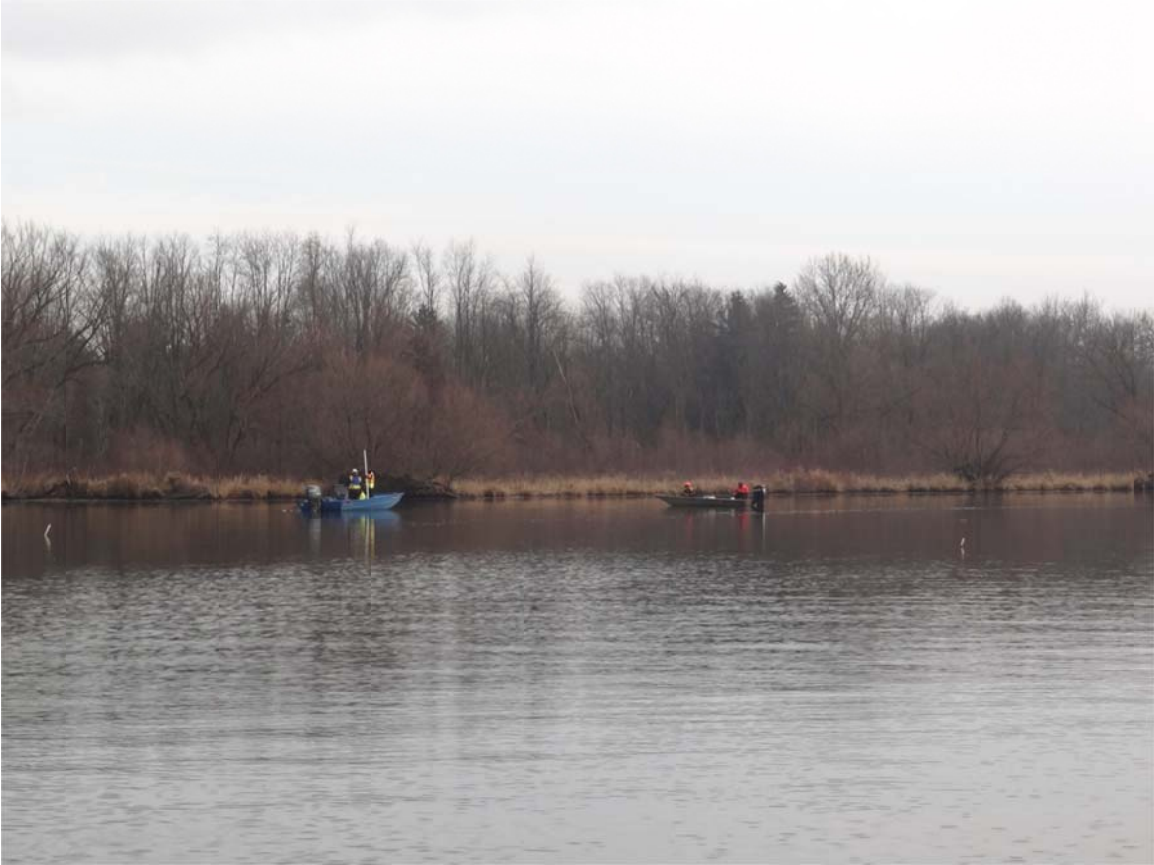
**17. Bathymetry crew operating in morning along RDB in Morrow Lake Delta.**

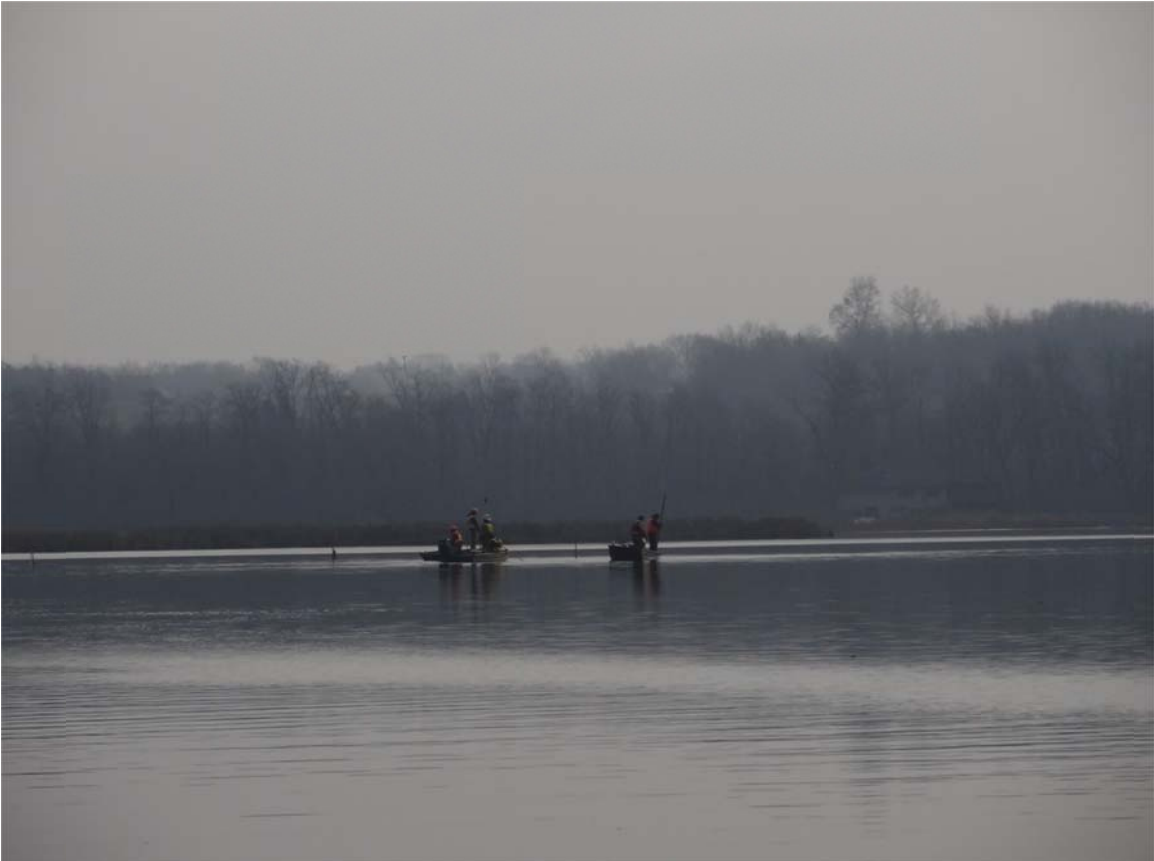
**18. Bathymetry crew operating in west end of Morrow Lake Delta.**

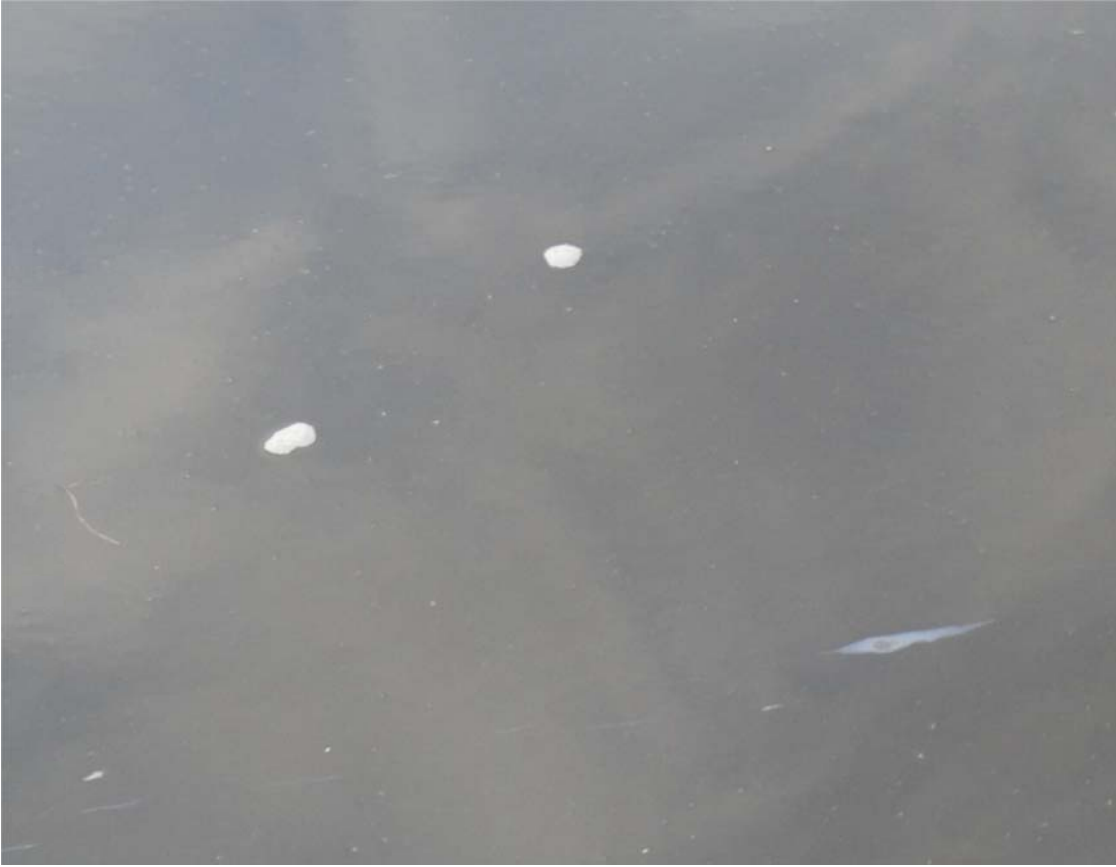
**19. Tar globules and sheen observed in north cove of Morrow Lake.**

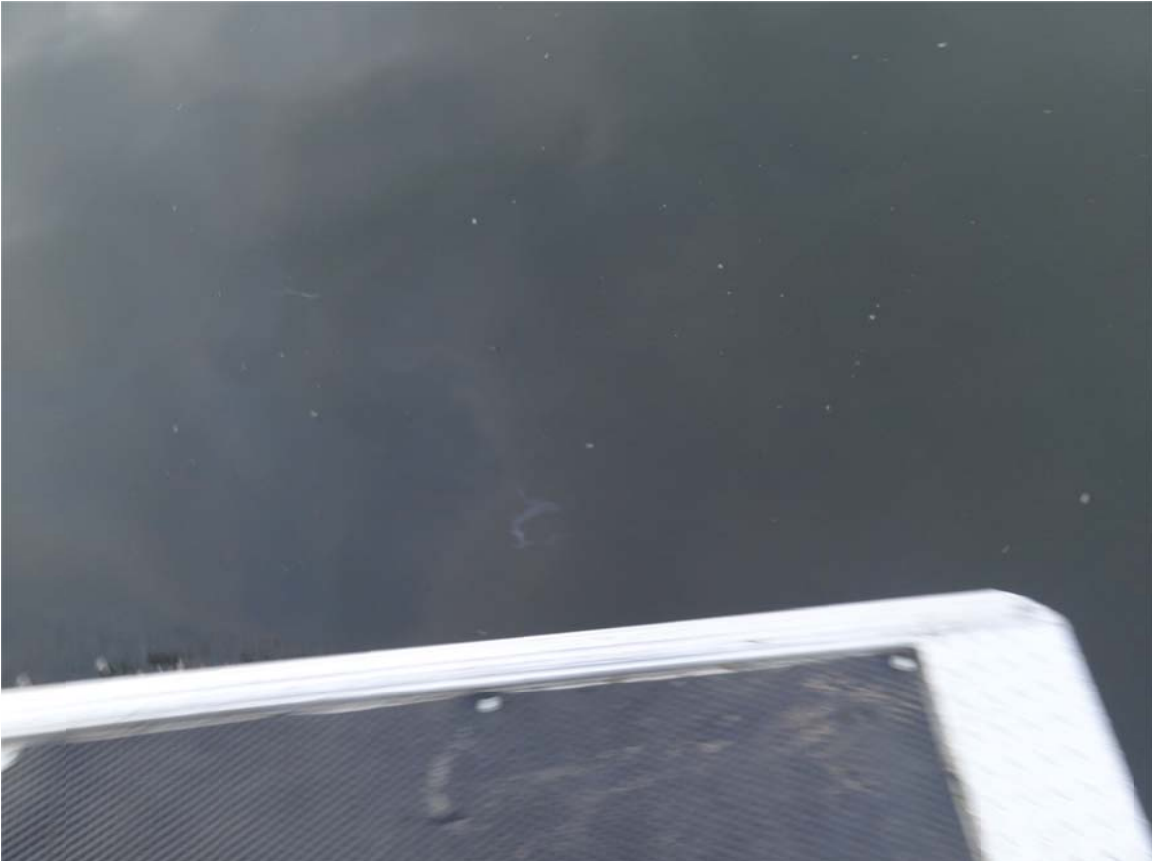
**20. Tar globules and sheen observed in south cove of Morrow Lake.**

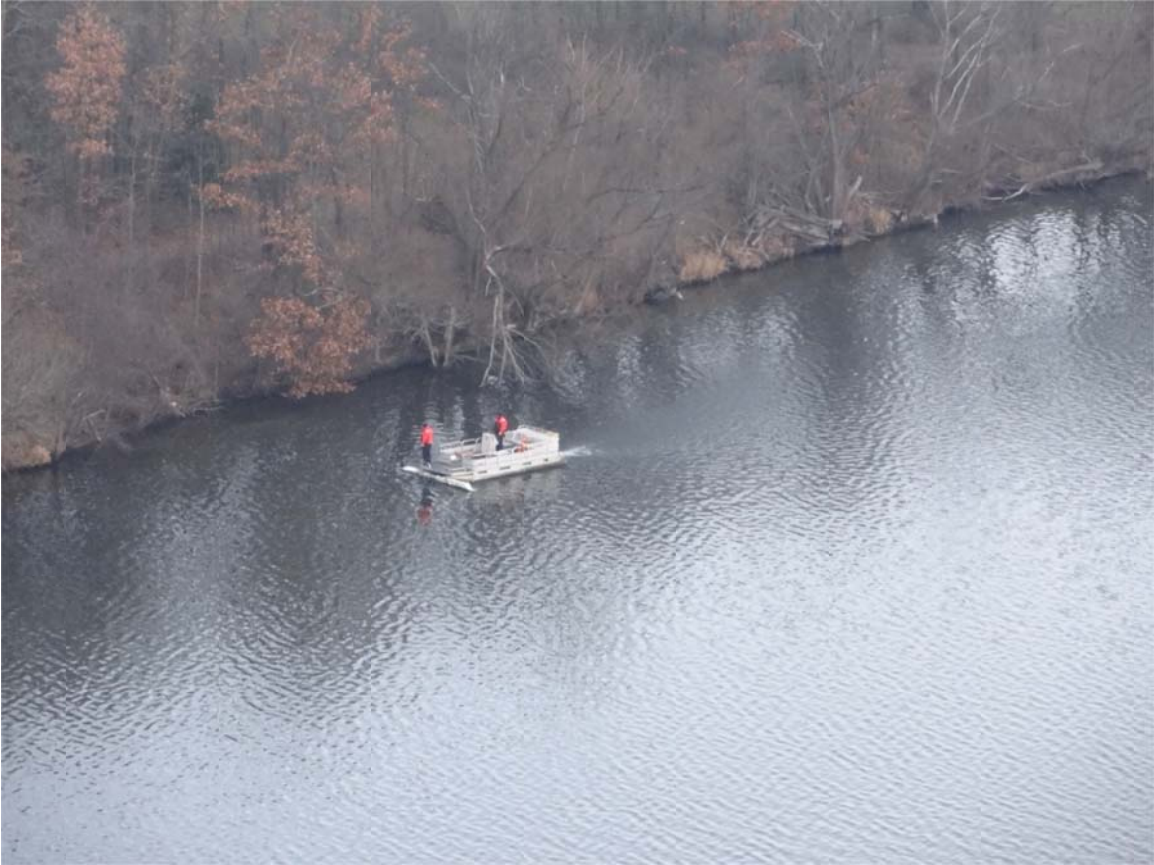
**21. Sheen sweeper boat operating in north cove of Morrow Lake following sheen sweep request by operations.**

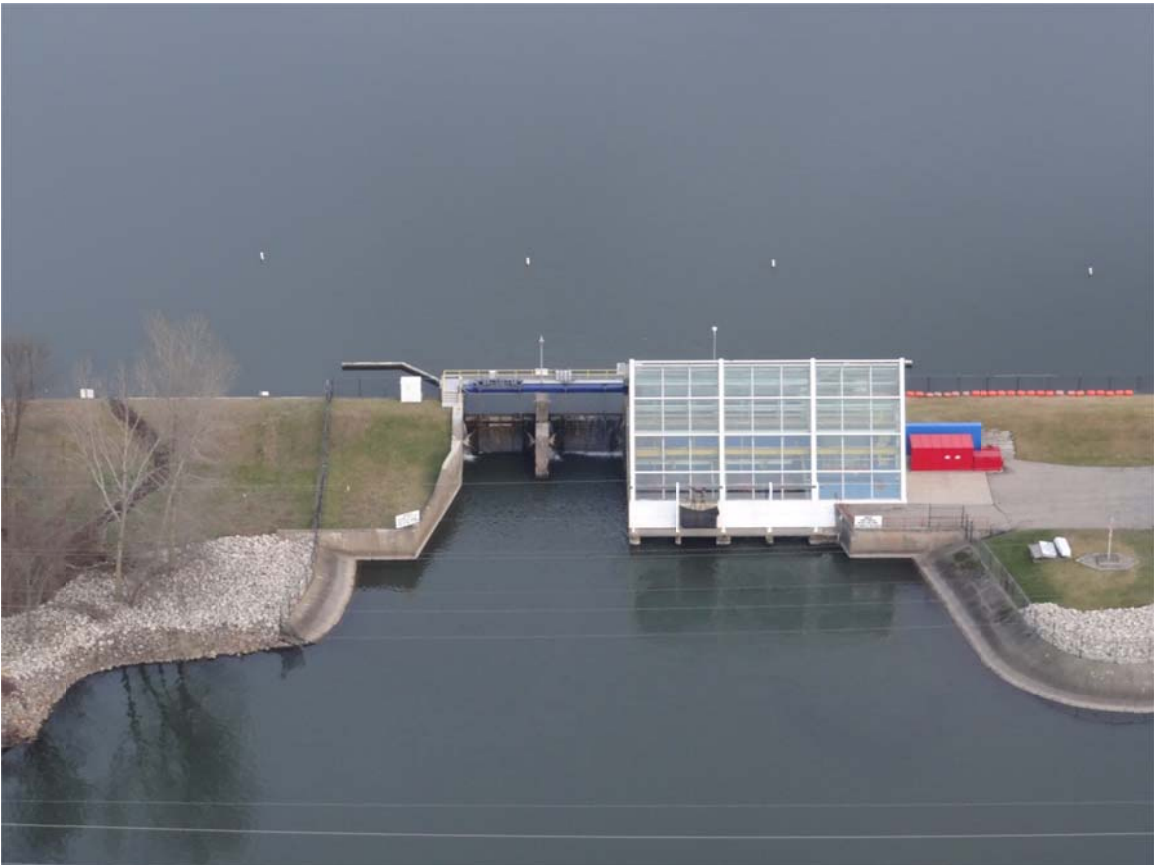
**22. Morrow Lake Dam, light flow observed over southern spillway of dam.**
